# Conservation of the Tulix Mul Mural

Pieta Greaves, Colleen Hanratty, Thomas Guderjan

Drakon Heritage, Maya Research Program, Texas Tyler University

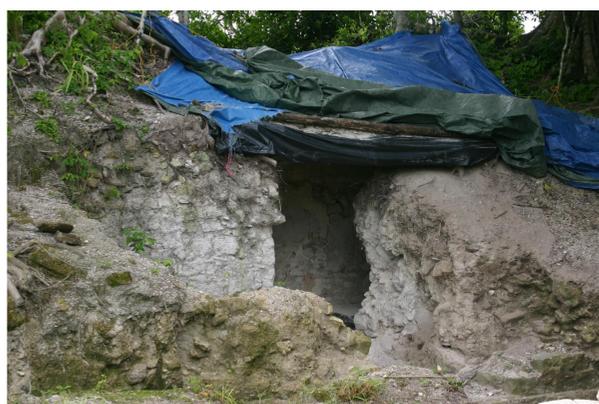
Structure 2 with door entrance to mural

The mural is located in the vaulted room of Structure 2, which is part of a partially excavated building complex. The room was filled with large uncut stones at the beginning of the late classic and the room was sealed. Areas of the original room have now collapsed and room is protected by wooden roof and tarpaulin which also extends over the doorway to protect the wall painting from the climatic conditions.

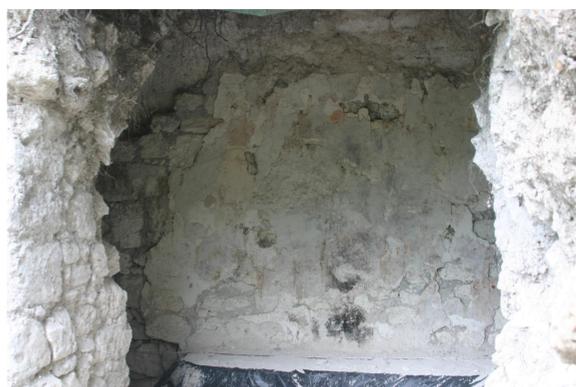
Mural over bench

The wall painting is 6m x 2m in size, the plaster once extended across the whole back wall but due had loss large areas over time.

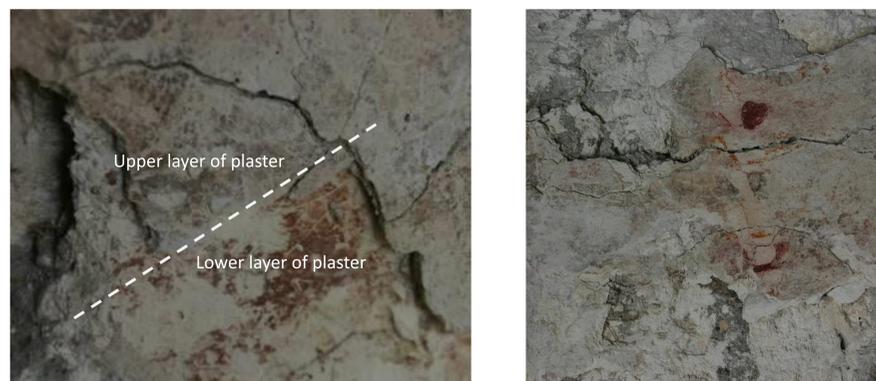
Two layers of plaster are visible both with painted details, an older layer one and a newer layer two, the lower plaster level is further decorated with red and orange pigment, it could not be determined if this is a simple or elaborate design.

Paint layers with red and yellow pigment

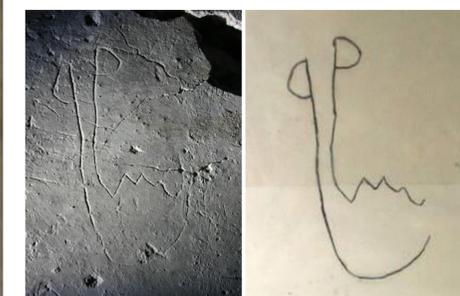
Along with the previously identified areas of painted plaster, eleven areas were identified with raking light that contained crude graffiti, scratched into the surface, although mostly unidentifiable in nature, deliberate shapes and forms could be distinguished.

Unknown design

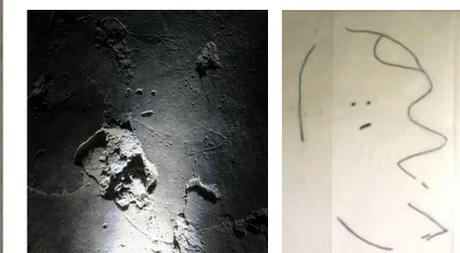
Unknown design

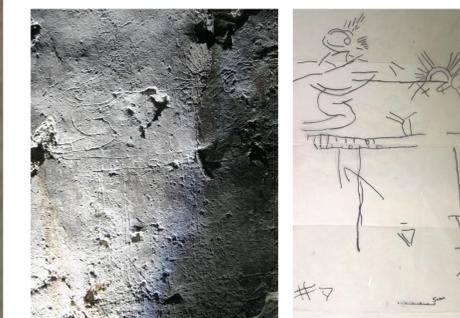
Human knelling on platform/sun design

The graffiti has been carved into multiple areas and into both the top and bottom layers of plaster further indicating the poor state of the mural when buried.

The thickness of the lines are variable, but none are thicker than 2mm. The freehand style of the designs allows for the observation to determine directionality of the line drawn where the line thins at the end of each stroke. Due to the hard nature of the plaster and the cleanness of the lines, it is likely that a lithic tool would have been used to create the designs.
